# Estuary Junction, Main Operational Observations

**Date:** Friday, 16 October 2026

## Executive Summary

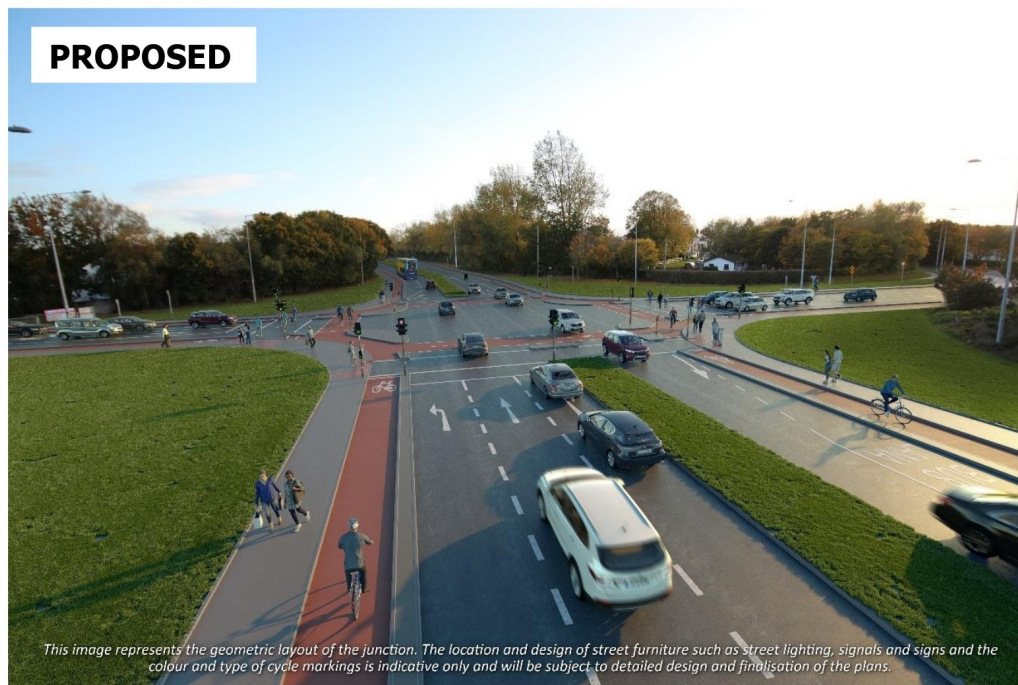
**Figure 6.2: Existing and Proposed Estuary Junction Layouts**

The problem was initially assumed to arise because the junction was unfinished, with the expectation that the remaining curved sections of the former roundabout might become slip roads. The published designs show that this is not the case.

Figure 3. 2020 consultation render of the proposed Estuary junction. The visualisation shows the intended finished geometry and does not show a separate vehicle slip road for the R125 Balheary Road west approach to the northbound R132.

This is an emergency mitigation for an immediate operational problem. The underlying HGV restriction is long term because the same restrictive geometry appears in both the consultation proposal and the later planning drawing.

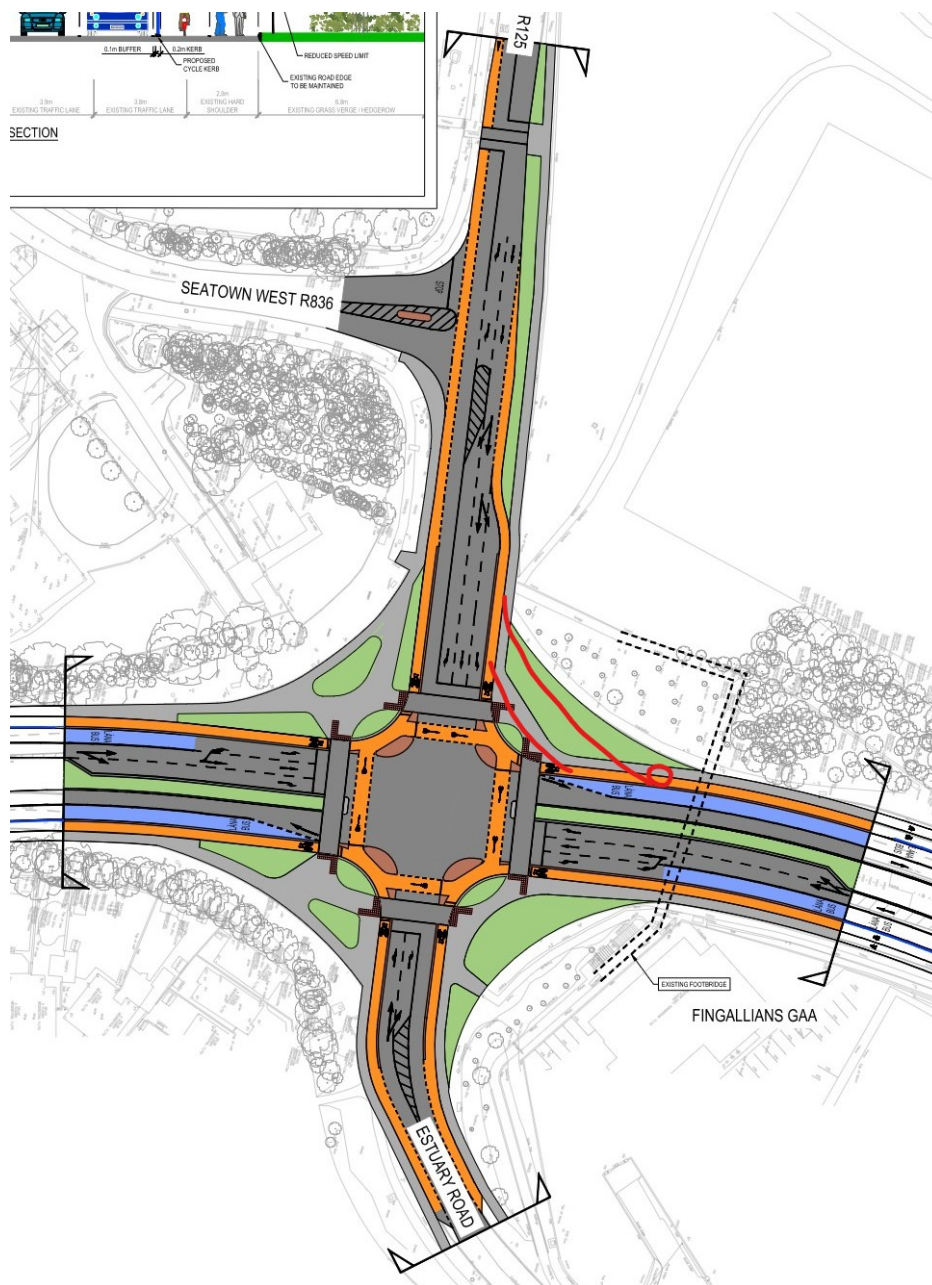
The turning geometry was observed to be too tight for HGVs approaching from the R125 Balheary Road from the west to complete the right turn onto the northbound R132 normally.

On a green signal, with the R132 on their left, HGVs must crawl towards the central island and then swing sharply left to obtain sufficient rear wheel clearance before completing the turn.

This necessary manoeuvre blocks following traffic and prevents left turning vehicles from moving until the HGV has cleared the junction.

Figure 1. Proposed temporary R125 to northbound R132 slip arrangement. Red line indicates the proposed temporary slip route using the former roundabout geometry. Red circle indicates the proposed stop point before joining the northbound R132. Annotated extract based on Drawing 200021-DBFL-RD-SP-DR-C-1107.

A temporary slip road could be formed using traffic cones along the remaining outer curve of the former roundabout. Left turning traffic from the R125 could use this temporary lane to join the northbound R132 separately from the main junction movement.

This would remove left turning cars from the road space currently required by HGVs and allow HGVs to make the right turn more naturally.

The simplest emergency arrangement would be a temporary stop sign at the end of the slip. Vehicles would stop and enter the R132 when the normal junction signal sequence creates a safe gap. When northbound R132 traffic is stopped at the signals, traffic waiting on the slip would naturally receive an opportunity to join.

If observation showed that the stop controlled arrangement was insufficient, a temporary signal connected to the existing junction sequence would be the next option.

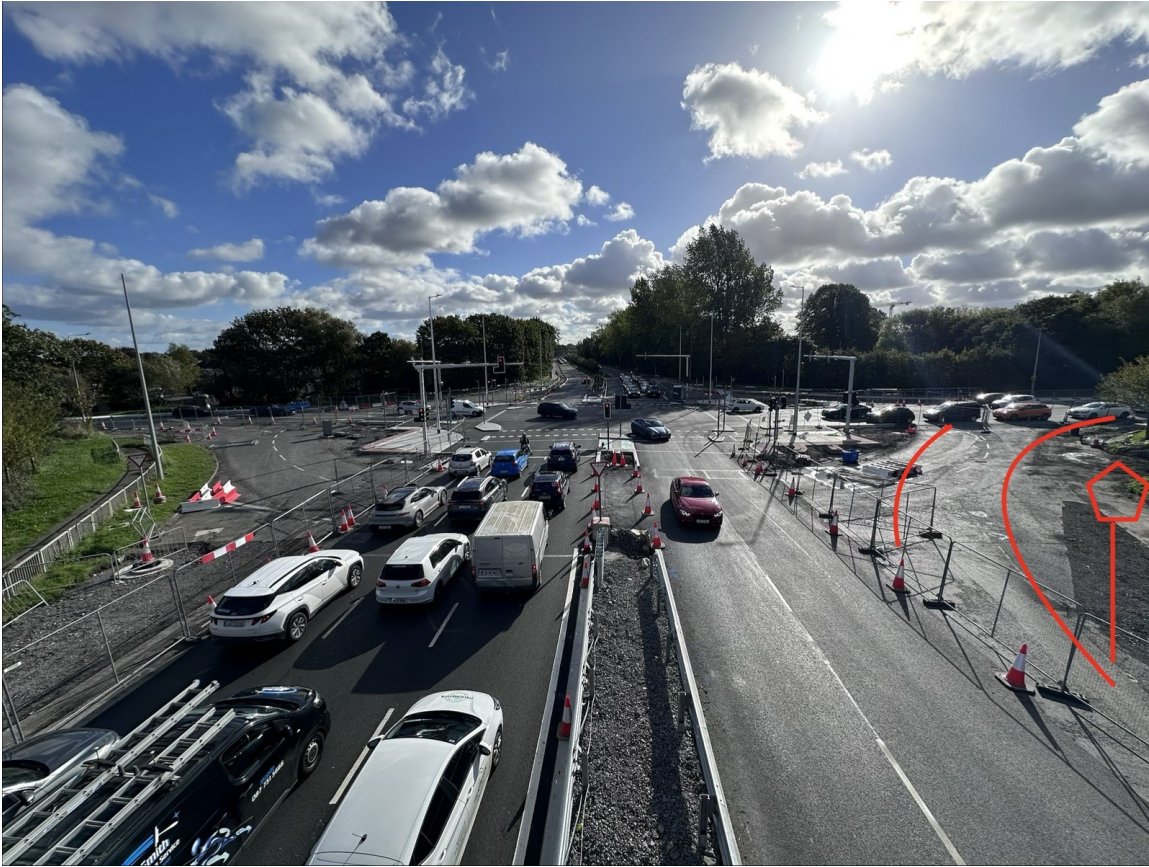
Figure 2. Live view of the Estuary junction during current works. The red annotation shows the same potential temporary slip route and stop controlled merge point in the existing physical space.

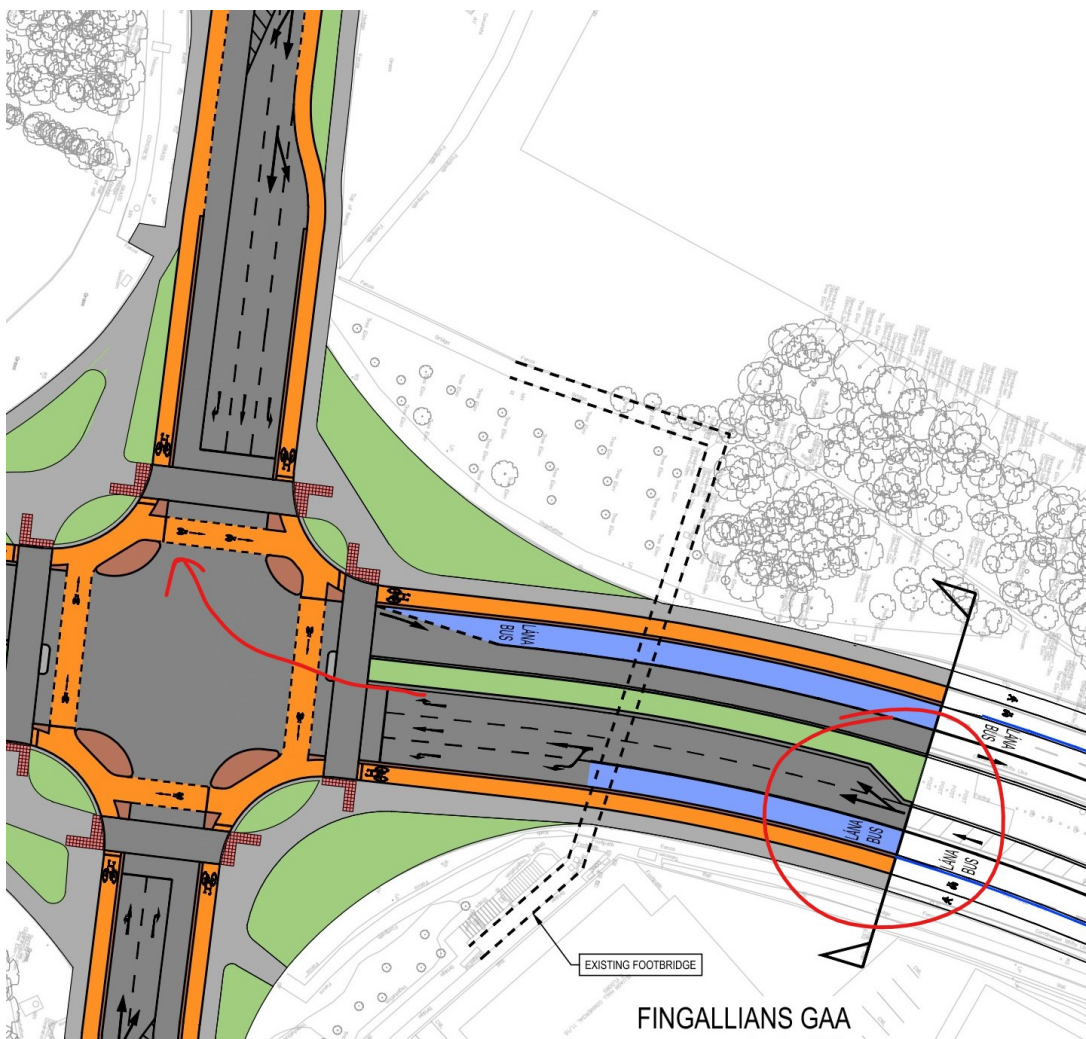
The dedicated right turn lane cannot accommodate the observed demand and the signal phase does not reliably clear the queue. Once the lane fills, waiting traffic backs into the main R132 lanes and reduces through capacity for Right and through traffic causing a tailback.

Figure 4. Northbound R132 right turn onto Balheary Road West. Annotated extract showing the dedicated right turn storage lane. The issue is not the absence of a turn lane, but that the movement still cannot deal with the volume of right turning traffic and the queue backs into the main R132 flow.

Observed demand for this movement is greater than the junction can reliably discharge. Once the turning lane fills, the queue extends backwards into the main R132 traffic lanes. Vehicles travelling straight through the junction are then obstructed by traffic waiting to turn right.

The underlying problem is therefore a combination of storage capacity and discharge capacity. The right turn signal phase does not consistently clear the volume of traffic waiting to turn onto Balheary Road West.

During the field observation, approximately 20 vehicles cleared during one right turn phase, yet the demand was sufficient for the turning queue to build again shortly afterwards.

**Observed cycle:** the right turn lane fills; the queue reaches the through lanes; R132 through capacity is reduced; the right turn phase clears part of the queue; the lane then fills again.

The problem should not be understood simply as a short lane. It is a movement with insufficient overall capacity because the available storage and the available green time together are not enough for the level of demand.

The northbound right turn requires urgent adjustment while the junction remains in its trial phase.

Signal timing should be calibrated against live observed demand, with the objective of clearing the turning queue before it repeatedly spills back into the R132 through lanes.

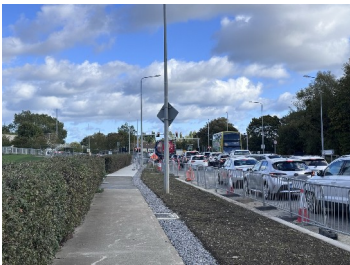
The effect is not confined to the immediate junction. Despite the main road works having been removed, a Swords Express service was observed taking approximately 10 minutes to travel from the Fire Station area to the new Estuary junction.

Traffic was observed backing more than 100 metres on Watery Lane, while traffic from North Street was also feeding into the same congestion.

A 33A driver surveyed at the location reported being approximately 10 to 15 minutes behind schedule.

| Traffic merge form North Street onto Balheary 33 + 41 bus delays | Gridlock between Firestation and Junction R132 in background | Watery Lane and North Street Gridlock feeding into Balheary Road R |
